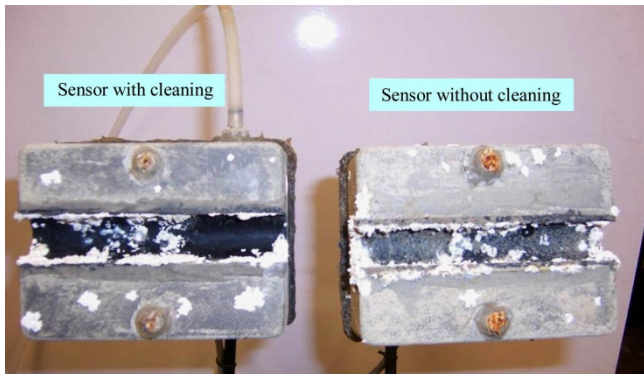
Figure 5 Photographs showing clay/silt fouling and bacterial fouling on sensors after a 40 d cleaning experiment

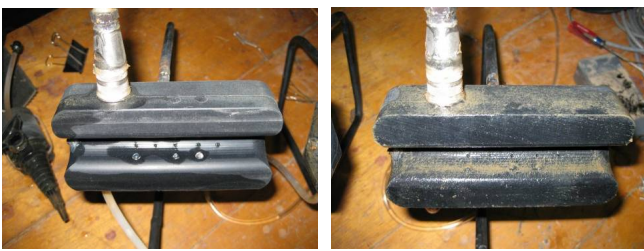
Sensor with air-blast cleaning      Sensor without air-blast cleaning  
a. Side view

Sensor with air-blast cleaning      Sensor without air-blast cleaning  
b. Bottom view

Figure 7 Photographs comparing sensors with and without air-blast cleaning after a 17 d cleaning experiment was completed

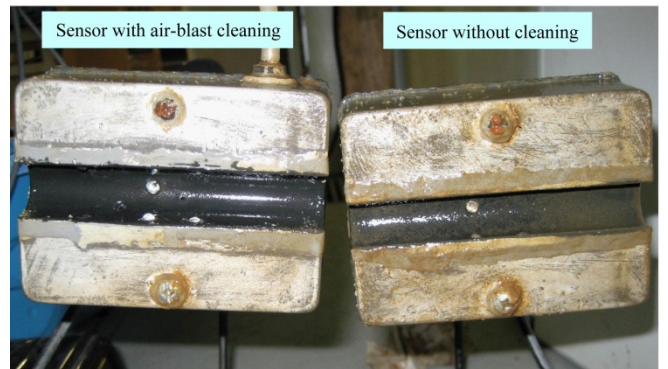
Figure 8 Aluminum sensors after working in water for 4 d
